Contract #: 04-0120F4Cty: SF/ALA Rte: 80 PM: 13.2/13.9File #: 69.28**WELDING INSPECTION REPORT****Resident Engineer:**Pursell, Gary**Address:** 333 Burma Road**City:** Oakland, CA 94607**Report No:** WIR-011971**Date Inspected:** 09-Feb-2010**Project Name:** SAS Superstructure**OSM Arrival Time:** 700**Prime Contractor:** American Bridge/Fluor Enterprises, a JV**OSM Departure Time:** 1900**Contractor:** Zhenhua Port Machinery Company, Ltd (ZPMC), Changxing Island **Location:** Shanghai, China**CWI Name:** NA**CWI Present:** Yes No**Inspected CWI report:** Yes No N/A**Rod Oven in Use:** Yes No N/A**Electrode to specification:** Yes No N/A**Weld Procedures Followed:** Yes No N/A**Qualified Welders:** Yes No N/A**Verified Joint Fit-up:** Yes No N/A**Approved Drawings:** Yes No N/A**Approved WPS:** Yes No N/A**Delayed / Cancelled:** Yes No N/A**Bridge No:** 34-0006**Component:** OBG.**Summary of Items Observed:**

WELDING INSPECTION REPORT

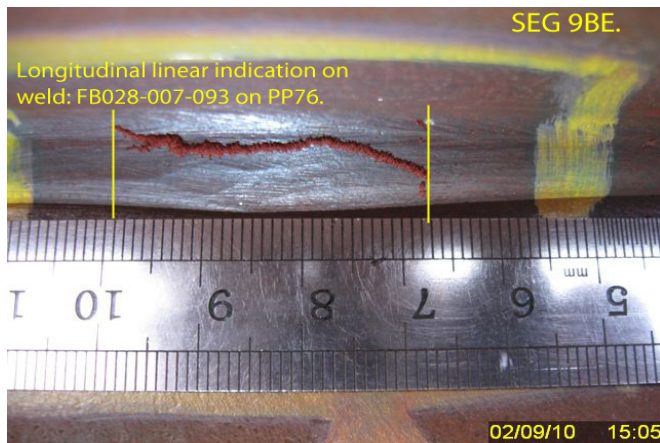
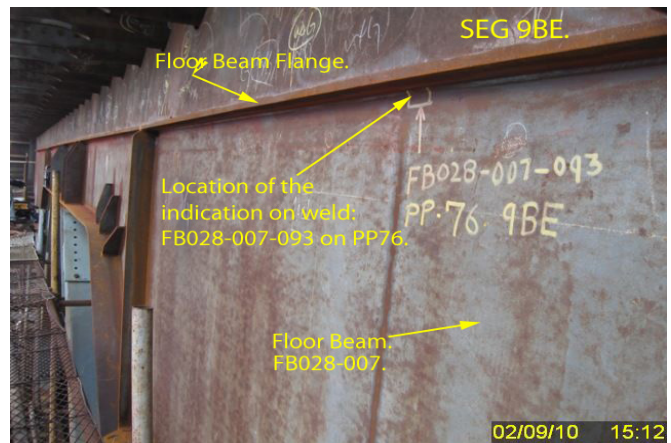
1) PP76-FB028-007 – 093.

- During inprocess visual inspection of the above mentioned weld, this QA observed One (1) longitudinal indication.

- This was confirmed with MT wherein, One (1) longitudinal crack measuring approximately 33mm length was observed.

- The member(s) are identified as OBG components – Floor Beam & Floor Beam Flange on PP76.
